E I F S P O R T O B E L L O ?

EIFS (Exterior Insulation and Finish Sytems a.k.a. Synthetic Stucco) clad residences

Chicago, Illinois
& St. Charles, Illinois

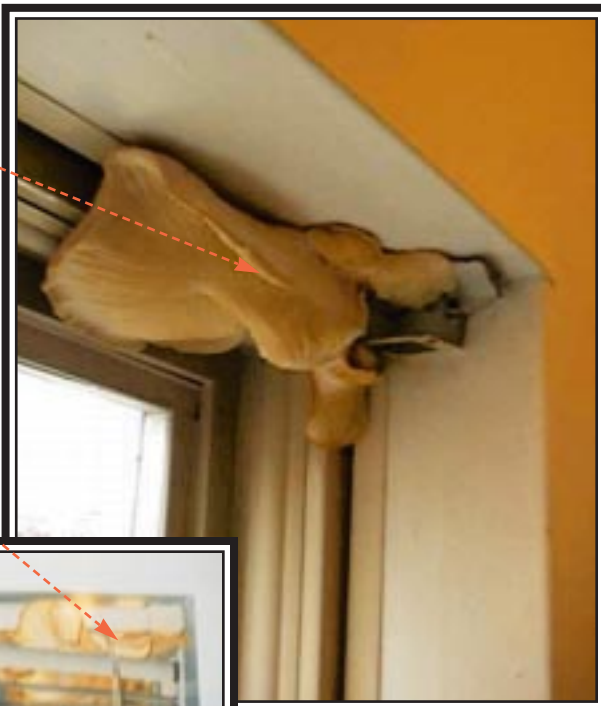
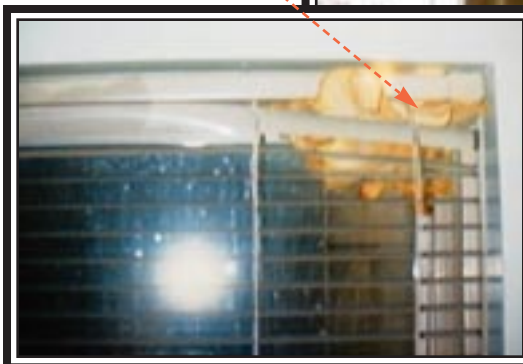
This 3 year old Chicago Home is part of a very large development. All of these homes have potential structural damage, moisture infiltration, and associated environmental health hazards.

Mushroom/ fungi growing at window head due to elevated moisture levels

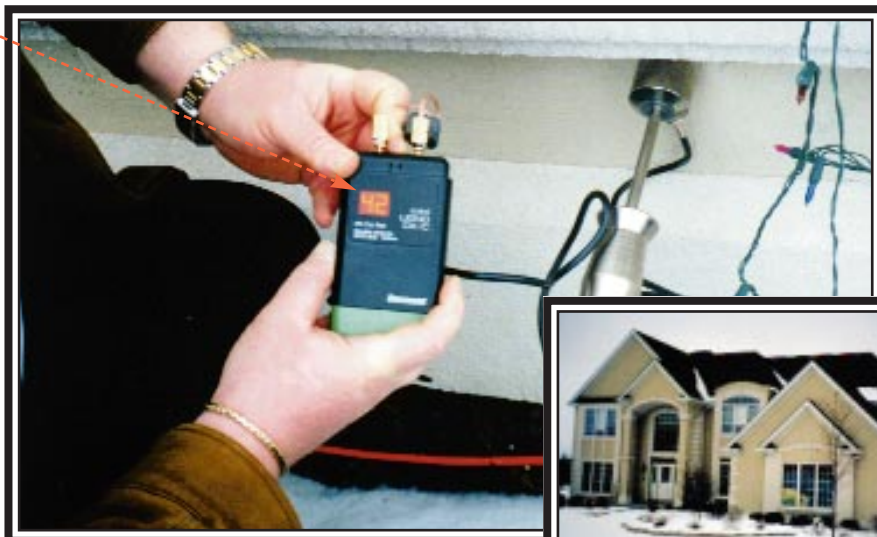
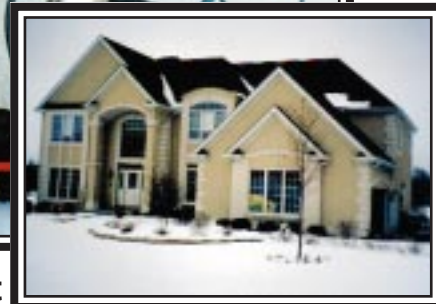
R O T T I N G / W E T W O O D

St. Charles Home Built 1995-96 occupied April 1996. Home shows severe moisture penetration and saturation. When tested for moisture , the wood structure beneath has a 42% moisture content. (Much higher than the normal 8% -12%.)
